Asbestos Program Update

Volume 4, Issue 1

Ohio Department of Health

Visual Inspections Prior To Final Air Clearance

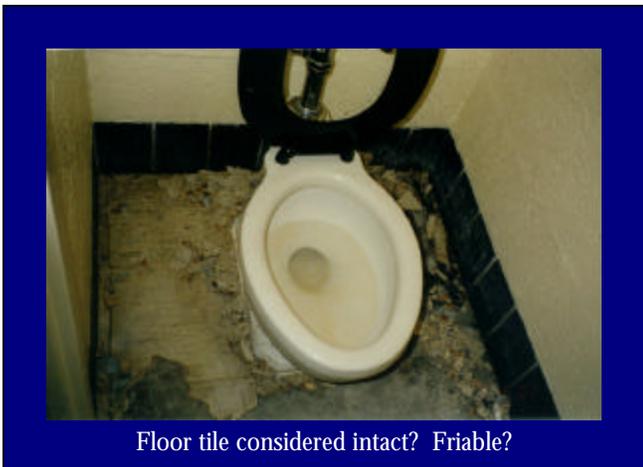
Floor tile considered intact? Friable?
